Seattle Wide-area Information For Travelers

Communications Study

Contract Number: WSDOT Y-5908

October 19, 1998

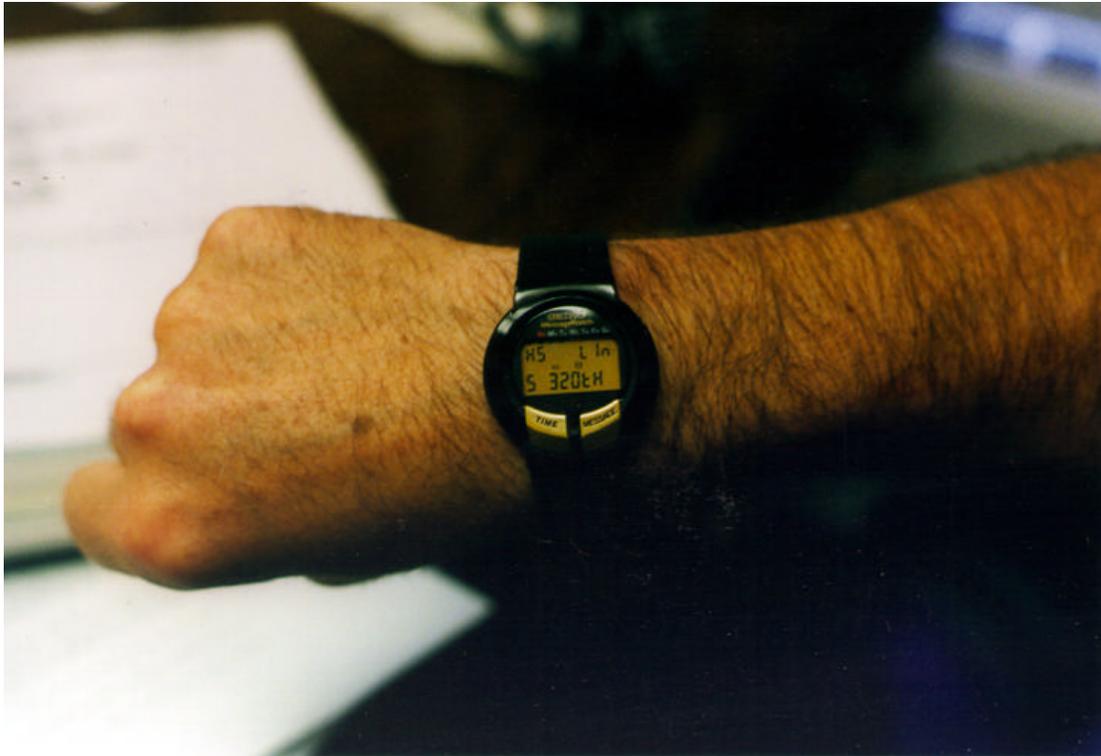
Figure 1-2. Seiko MessageWatch.

These devices are commercially available and widely used in the Seattle area to deliver personal-paging services and “information service” messages. Current information-service messages include weather forecasts, financial market summaries, local sports scores and winning lotto numbers. SWIFT traffic messages were featured as an added information service.

SWIFT test participants who used the Seiko MessageWatch supplied information to the Evaluator about the usual routes, directions, days and times of the day they traveled. Traffic messages indicating the location and severity of traffic problems that the user might encounter were sent based on the resulting travel profile. Because the Seiko MessageWatch stored eight messages, only traffic problems that resulted in substantial delays were sent.

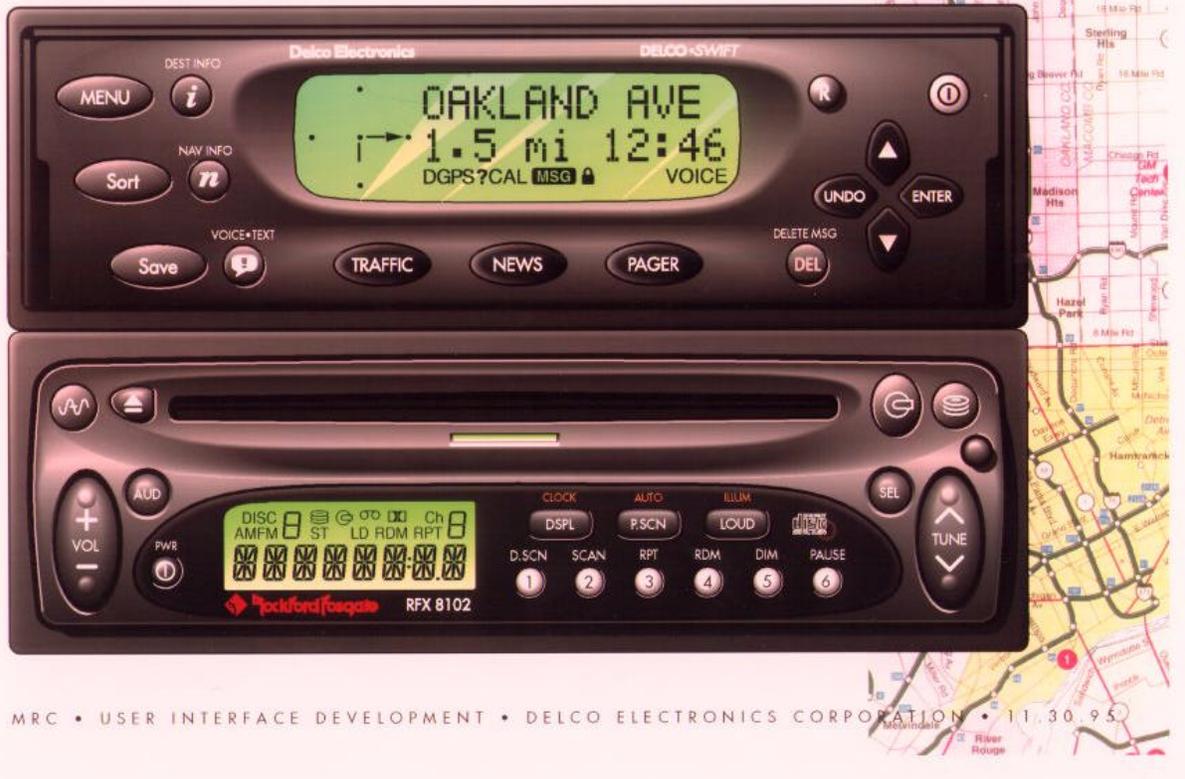
Figure 1-3. Delco In-vehicle Navigation Device.

The Delco device included the capability to select destinations from a “Yellow Pages” directory of local landmarks, hotels, restaurants, businesses and street corners selected by the user. The GPS provided the current location of the vehicle and a directional display associated with the route guidance system indicated the direction (relative to the vehicle) and distance to the selected destination. The stereo speakers were used to announce received messages.

Real-time traffic-incident information was transmitted over the Seiko HSDS. The HSDS receiver was built into the Delco in-vehicle navigation unit filtered out any messages that were outside a pre-defined distance (e.g., 20 miles) from the current location of the vehicle. The navigation unit also decoded upon demand the SWIFT traffic messages from text into a “voice” that provided incident details to the driver. Although messages were retransmitted every minute, only new or modified messages were announced to the driver.

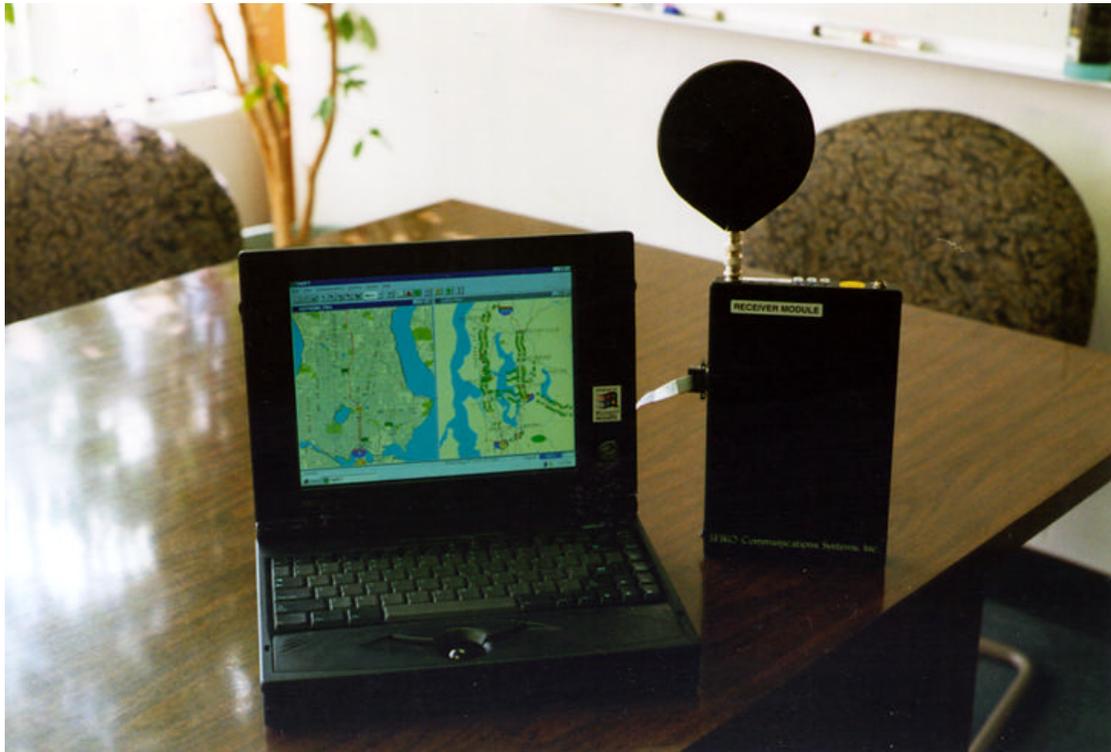
Figure 1-4. SWIFT Portable Computer and RRM.

All of the traveler information for SWIFT portable computers was displayed using Etak Geographical Information System (GIS) software to show the location of each piece of data. The software allowed the user to select the type(s) of information (i.e., traffic incident, speed/congestion or transit-vehicle location) to be displayed on a map of Seattle. A "Yellow

Pages" directory was also installed and linked to the GIS software to show the location of a selected business or point of interest. SWIFT portable computers also offered transit schedule information from static database tables inside the computer.

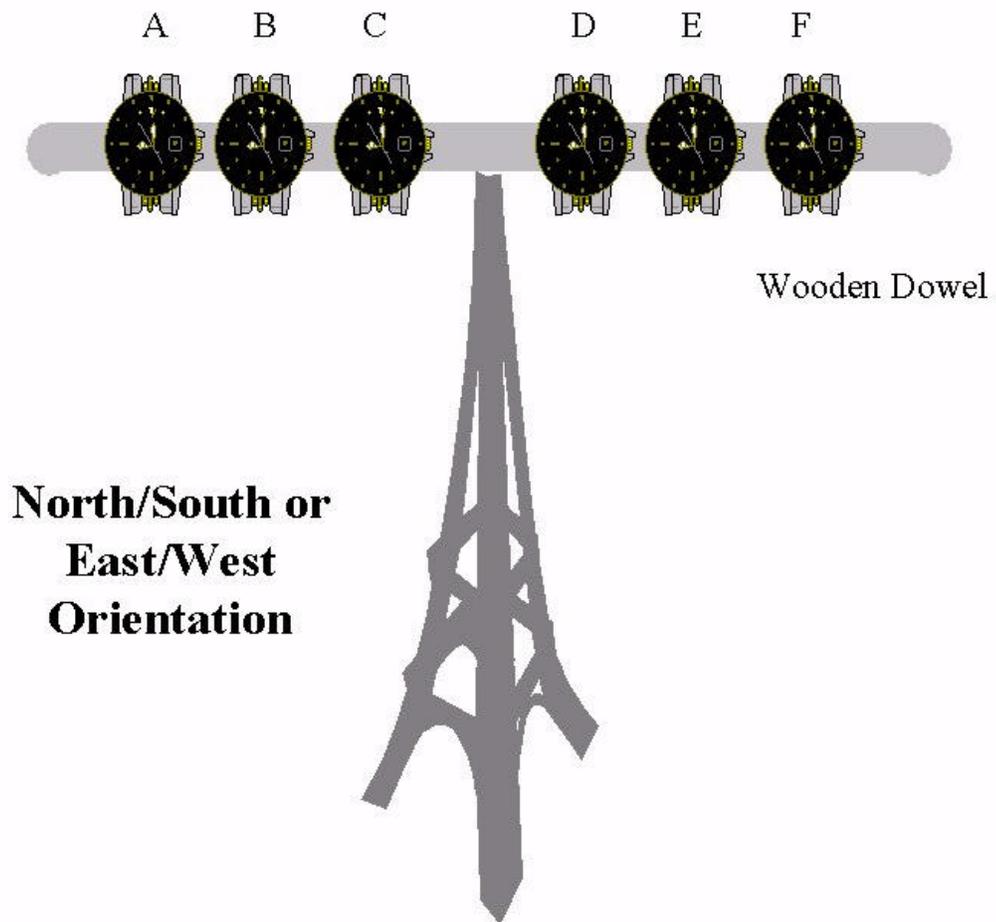
Figure 2-2. Drawing of Seiko MessageWatch Horizontal Test Configuration.

period in order to collect a statistically relevant number of sample points. To reduce the duration of the watch test, six watches were included in the test configuration. By allowing the test to run for an hour or more, about ten measurement points per watch, or sixty total, were collected.

Receipt of messages by SWIFT portable computers (i.e., Toshiba Satellites) was measured at each site by using RRMHOST software supplied by Seiko. Typically, both units were initially placed outside the data-collection van, with one unit oriented in the North/South horizontal direction and the other in the East/West horizontal direction. The units were checked frequently to ascertain if they locked onto one of the seven HSDS stations. If either unit was in a slow-scan mode, a fast scan was initiated. Otherwise, the RRMHOST software, which was modified by SAIC technicians to record the receipt of information at one-second intervals, logged the receipt of all information by writing it to a harddisk "logfile" for later analysis. Finally, both portable computers and RRMs were powered by using two DC to AC inverters plugged into the rear cigarette lighter jack in the back of the van used for testing.

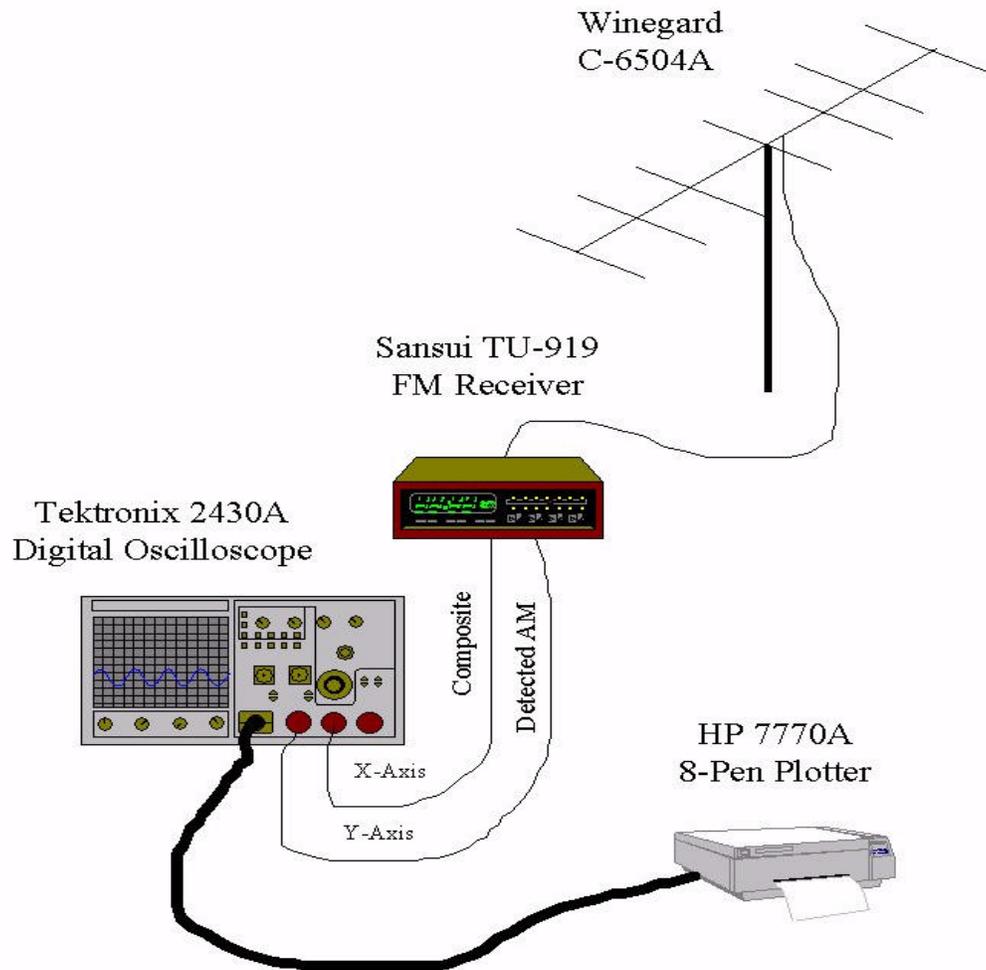
Figure 2-7. Multi-path Test Configuration Diagram.

For the purposes of the *SWIFT Communications Study* testing, a simple technique was employed to detect the presence of multi-path interference using the TREQ monitor system. This system was capable of being locked to a specific HSDS station. At test locations where poor reception was found, but where there was adequate RSL, a multi-path situation may exist. Since the azimuth (bearing angle) from the test location to the specific transmitter was known in advance, it was possible to replace the omni-directional test antenna with a directional antenna pointed directly at the transmitter. By using this method, one can compare the two sets of measurements and observe changes in the BER and PCR from the particular station. In cases where significant multi-path was indeed present, the directional antenna technique greatly improved receiver performance. In addition, experimental measurements were also made at varying off-azimuth bearings up to $\pm 25^\circ$. This method can help identify if there is more than one multi-path signal and generally from what direction(s) they are being received. However, due to the fairly wide pattern of this directional antenna, exact measurements were not able to be taken.

A Winegard Directional FM antenna, Model # CA-6065, was used during the testing to isolate observed signal degradation possibly caused by multi-path environments. This antenna, designed with 10 dB of gain, was mounted on a 5 foot 1¼" steel mast which was supported with a 3' roof-mount tripod. The beam-width of this antenna across the FM band was 60 degrees or less, with a fast drop-off in received signal level beyond this point. Consequently, when this antenna is aimed at a station, the level of multi-path will be significantly reduced if the received signal is originating from angles greater than ± 30 degrees. An improvement in BER/PCR over that measured with the OMNI antenna configuration strongly suggests that the cause of poor performance may be

- Step 5B: By pointing the directional antenna “off-axis” in incremental steps, determining if there was another direction at which the RSL, BER and PCR was also significantly improved

- Step 5C: Use the directional antenna with a Sansui FM receiver and a Tektronix 3036A oscilloscope to measure the amount of detected audio present in the suspect signal
- Step 6: A manual log of all test-equipment settings, locations and physical environments was maintained for all sites tested.

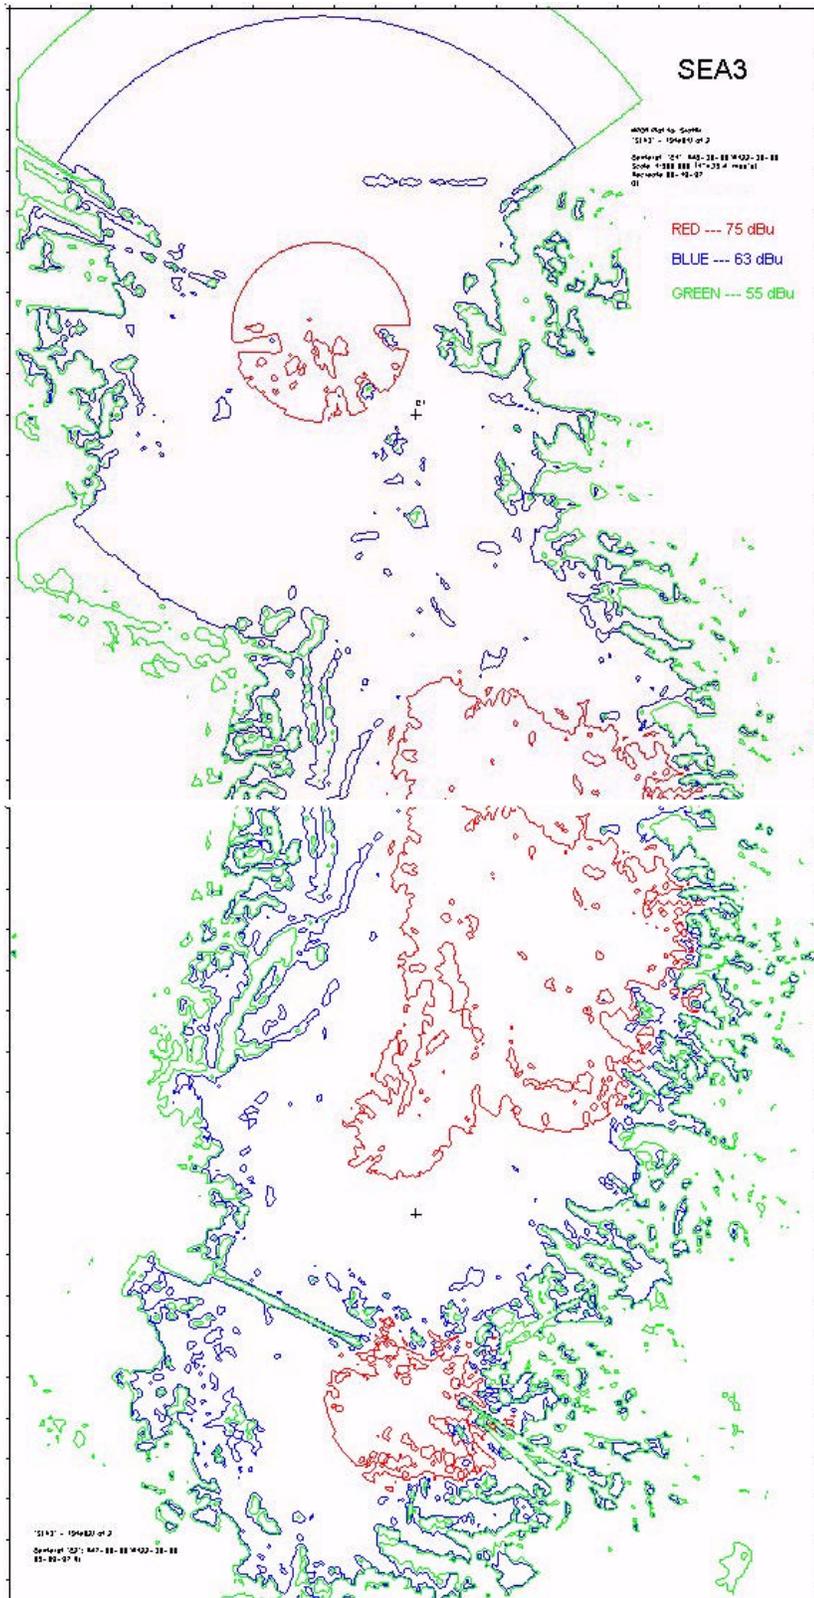
Figure 3-1. Composite Predicted Received Signal Levels for Seiko MessageWatch.

Composite, predicted RSL for Seiko MessageWatches is shown in Figure 3-1, while the same information is presented in Figure 3-2 for SWIFT portable computers. These data, derived from information supplied by Seiko, indicate that a 90% RSL is predicted for both devices across the majority of the SWIFT HSDS coverage area. Also provided by Seiko, on a 1:250,000 scale, were individual RSL contour plots (calibrated to the Seiko MessageWatch) for the seven HSDS stations in the Seattle area.

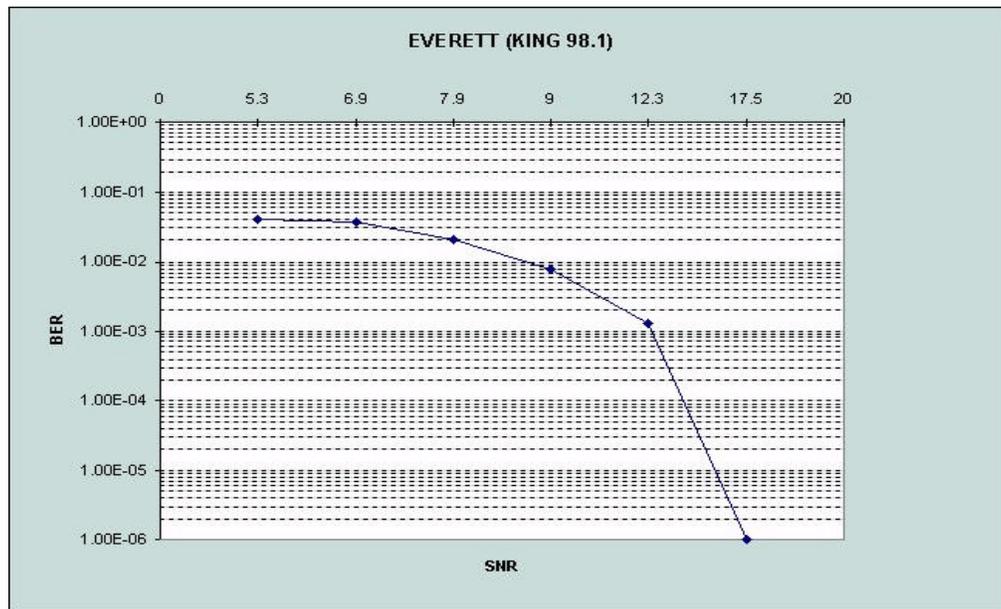
Figure 3-10. BER versus SNR Performance at Location #4 Using A Directional Antenna.

At this test location, the initial data-collection effort was flawed by an apparent loss of Seiko test messages. A review of the seven terrain profiles revealed signal occlusions from every station except KING. Interesting enough, KING with a significant signal level of -63 dBm, still performed very poorly at approximately 30%. The BER and PCR performance curves are shown in the Figures 3-10 and 3-11, respectively. Also, please refer to the performance analysis spreadsheet for test location #4, shown in Figure 3-12. This outcome appeared to be the best indication so far of severe multi-path interference. Similarly, the two RRM devices were locked onto KING at 98.1 MHz, but their message performance was poorer than normal in the 70% range. The analysis and discussion of the multi-path experiment at this location is discussed elsewhere in this section.

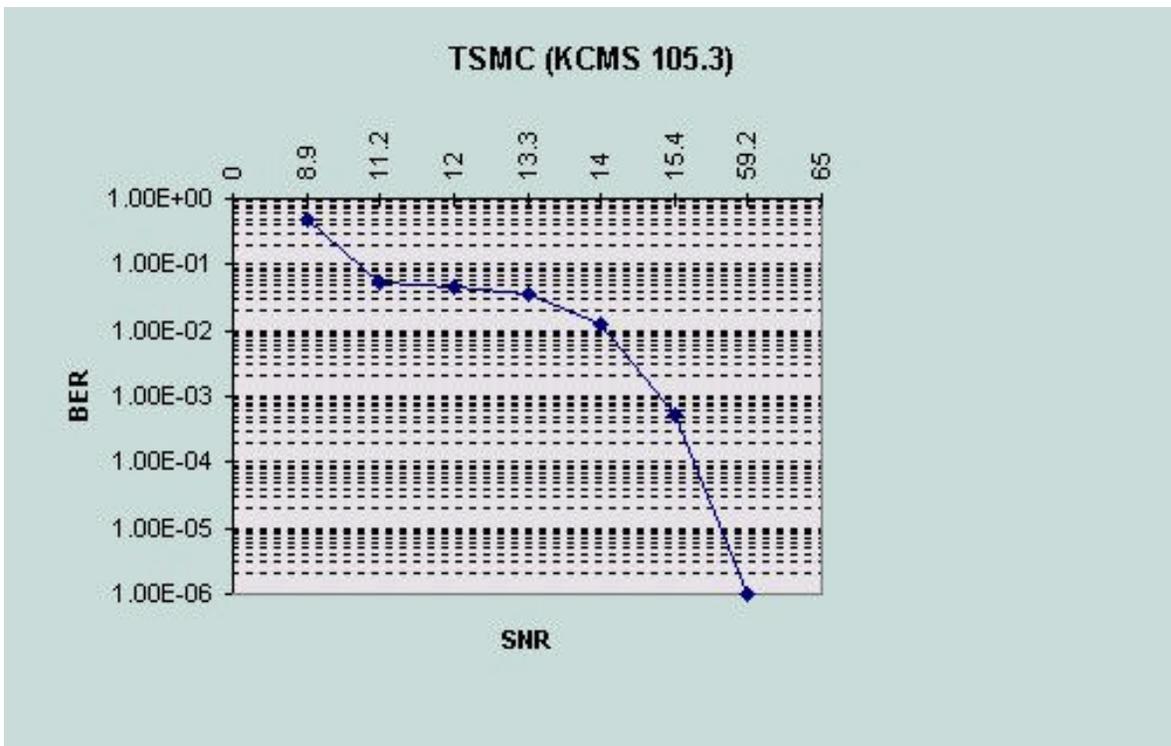
Figure 3-16. BER versus SNR Performance Characteristics for Location #6.

Conditions at this test location initially indicated that a multi-path environment might be the cause of the inability to take data from six out seven FM stations. After reviewing the transmission path terrain profiles, the results suggested that all but two had significant terrain blockages and six of seven were at a distance of about 20 miles or more. KCMS, unlike any other test was very close, 1.8 miles, with a -20 dBm signal which overwhelmed the RRM's and watches, causing them to lock on hard to the 105.3 MHz frequency. Manually forcing the watches to scan did not change the results. The only other station for which data was able to be collected on the TREQ was KAFE, with an RSL of -70 dBm. Figures 3-16 and 3-17 illustrate the BER and PCR curves for test location #6, respectively, while [Figure 3-18](#) shows the performance analysis spreadsheet for location #6.

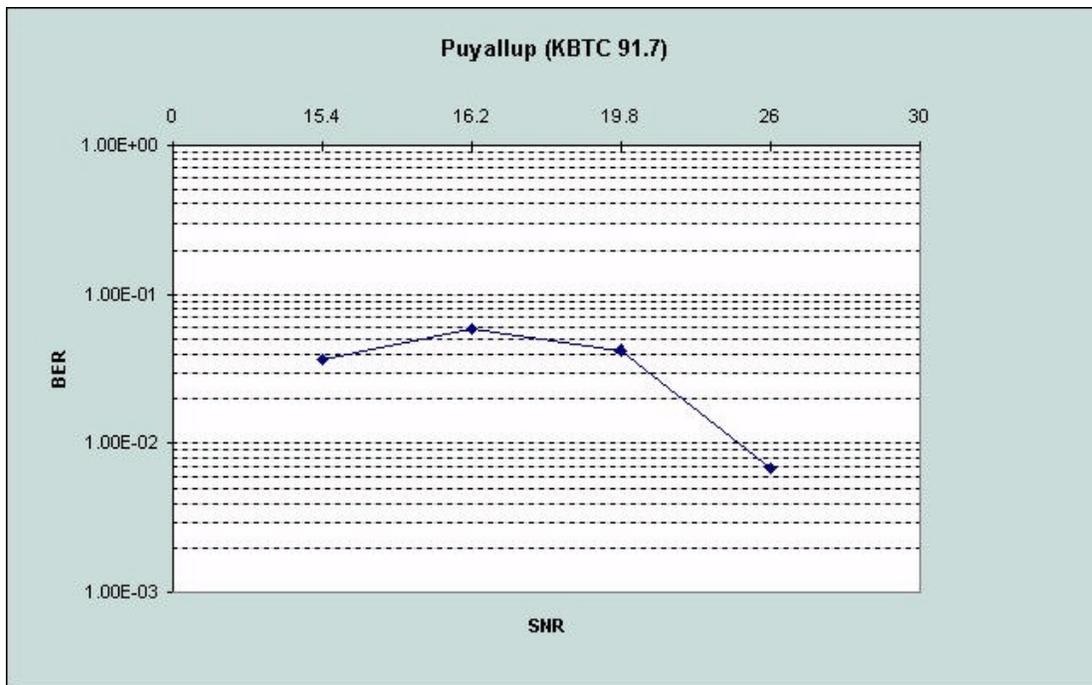
Figure 3-22. BER versus SNR Performance for KBTC at Site #8.

Figures 3-22 and 3-23 illustrate the BER and PCR versus SNR performance exhibited by signals received from KBTC. In addition, Figure 3-24 shows the summary performance analysis spreadsheet for data collection efforts made at test site #8.

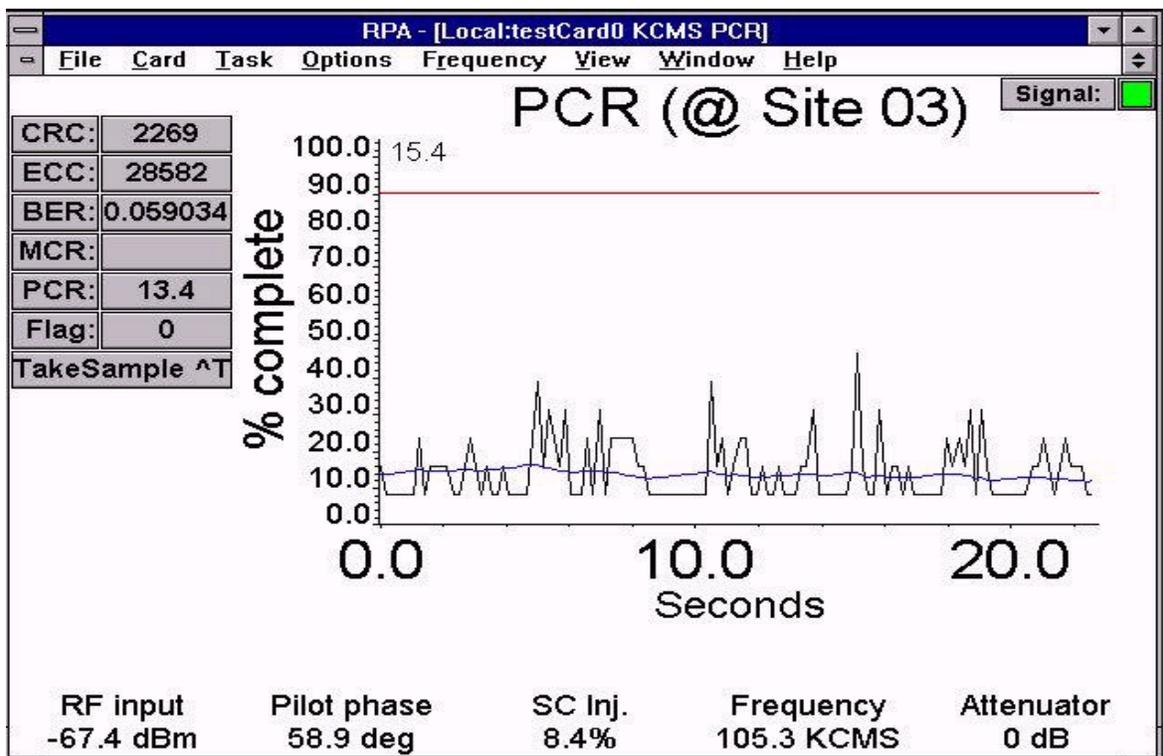
Figure 3-25. Suspected KCMS Multi-path Signal Measured at Site #3 with Omni Antenna.

There was an indication of multi-path problems from KCMS at this test location. The method used to determine if this interference could be mitigated was change receiver antennas on the TREQ system from the calibrated omni-directional dipole to the more directional FM antenna. By adjusting the signal attenuation to equalize the difference in gain between the two antennas, approximately 10 dB the effective directional pattern might reduce the sidelobe signals enough to improve the measured performance. Figure 3-25 shows the PCR performance for station KCMS, as measured by using the omni-directional antenna.

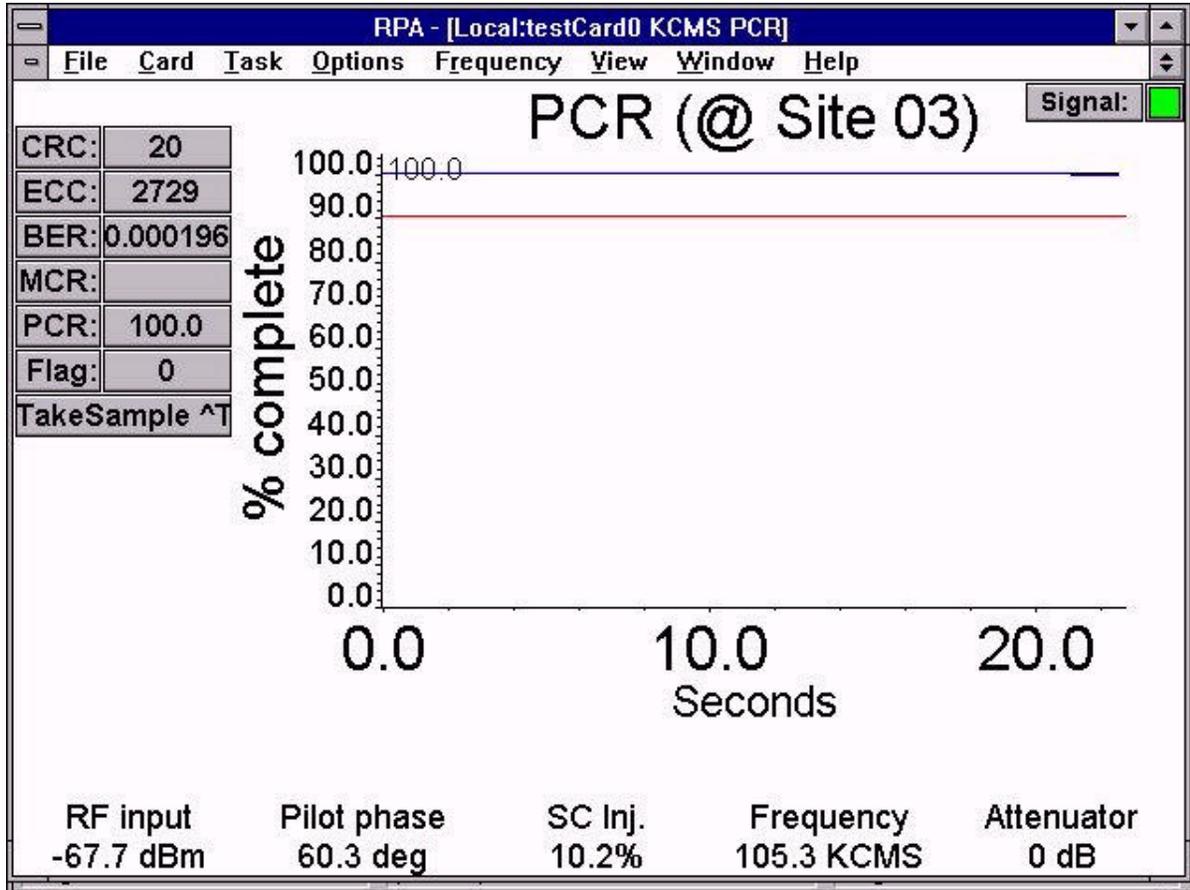
Figure 3-26. Same KCMS Multi-path Signal Measured at Site #3 with Directional FM Antenna.

The data recorded here is PCR and is shown to be about 10%, the effective BER is $5.9E-2$. When the directional antenna is connected to the TREQ signal input, the resulting improvement in PCR and BER reasonably suggests that the signal shown in Figure 3-25 was subjected to significant multi-path interference. This result is shown in Figure 3-26, below.

This result indicates the KCMS signal shows a greatly improved PCR, approaching 90% with the directional antenna. In addition, the resulting BER has now been reduced to an exceptionally low value of $1.9E-4$.

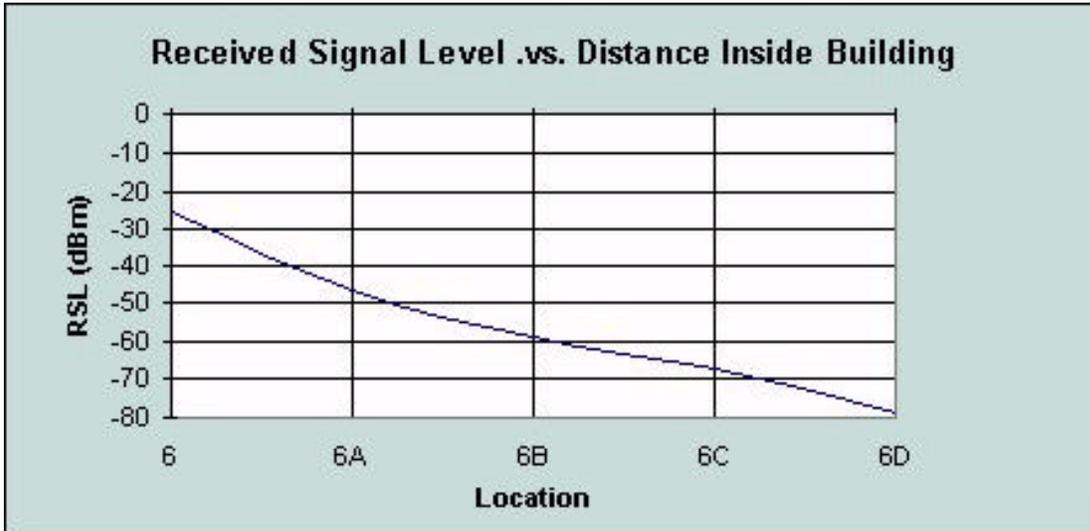
Figure 3-29. TSMC Inside Building Measurement of RSL at Four Locations.

Figures 3-29, 3-30 and 3-31 show the measurements taken at increasing distances inside WSDOT's TSMC building for RSL, BER and PCR, respectively. These curves confirm that the RSL, BER and PCR is degraded as distance inside the building increases.

These test measurements are useful in a general sense for predicting the effects of reductions in signal strength as the receiver is moved deeper into the building, away from the exterior walls. There are, however, many other variables which might influence this signal attenuation phenomenon. They are: building construction techniques and materials, frequency of signals being received, number, size and placement of windows, to name a few.

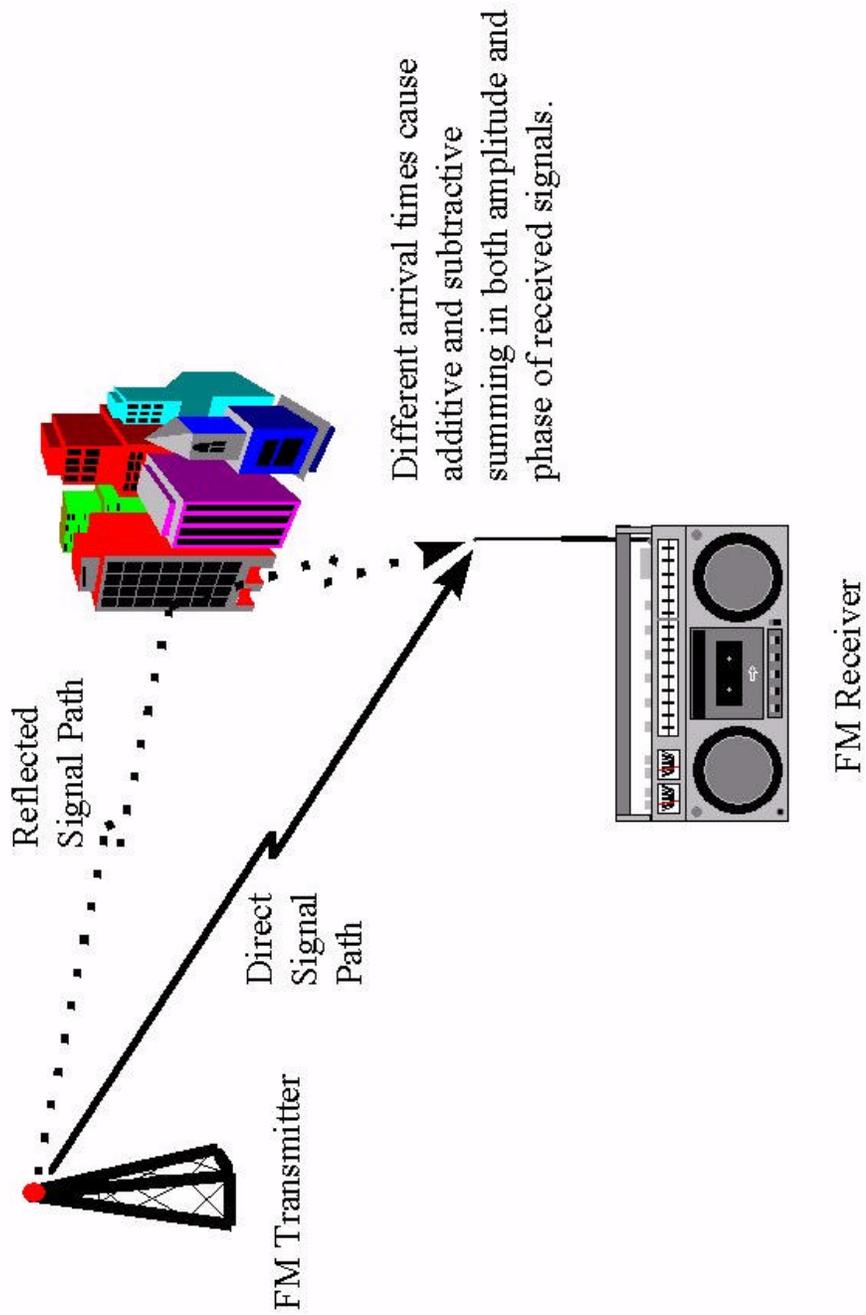
Figure 4-1. Example of Multi-path Propagation Mechanisms.

Even though the Seiko HSDS system performs reasonably well in the Seattle area, there are some regions where significant variations in terrain severely affect coverage. When this situation is found to be the case, it is recommended that more rigorous multi-path analyses and testing be performed in advance of system deployment. For example, where multi-path interference was observed in the tests, it was always associated with two/three high power stations. It is suggested that this multi-path problem might be mitigated by using a larger number of local, lower-power stations instead of higher-powered ones. A recommendation is made that further analysis into this issue be conducted and although it is uncertain how this may effect system costs, it is believed that coverage problems in these specific areas can likely be improved. Figure 4-1 illustrates one of several possible multi-path mechanisms.

Use of extremely high power FM stations may, in some instances, subject the HSDS to the occurrence of multi-path interference, particularly in hilly/mountainous areas. Ultimately, given the terrain of Seattle and despite the best efforts of the system designers, there will always be some locations that cannot obtain reliable reception. Analysis of the factors can make these areas arbitrarily small, but they will still occur. Strangely, the RRM equipped laptops seem to have more isolated blackout areas than the watch, despite the greater signal sensitivity of the RRM. Our only explanation is that the watches lower signal sensitivity put some of the multi-path interference below the receiver threshold, analogous to the effect of the directional antenna used with the TREQ.
